Situation Photo Log

Saturday, July 7, 2012

Kalamazoo River / Enbridge Spill

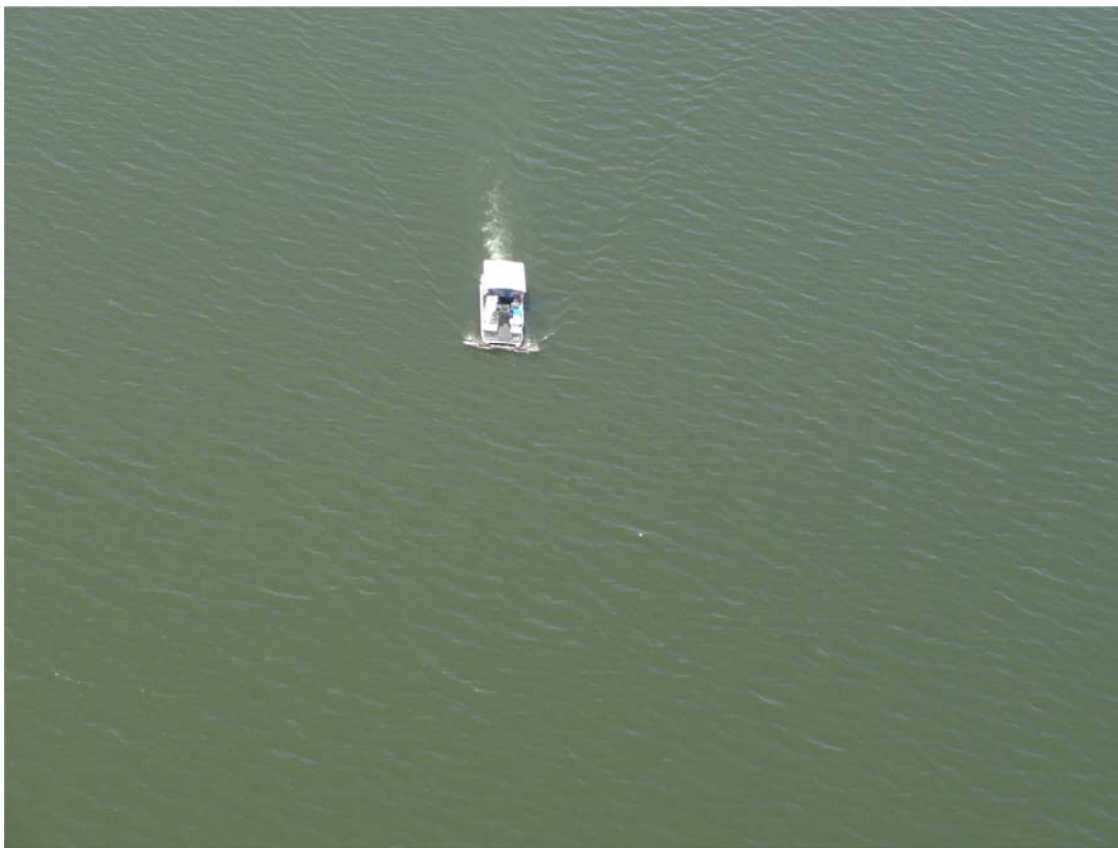
24. Morrow Lake, sheen sweeper boat observed in western portion of lake. NO sheen observed in lake.

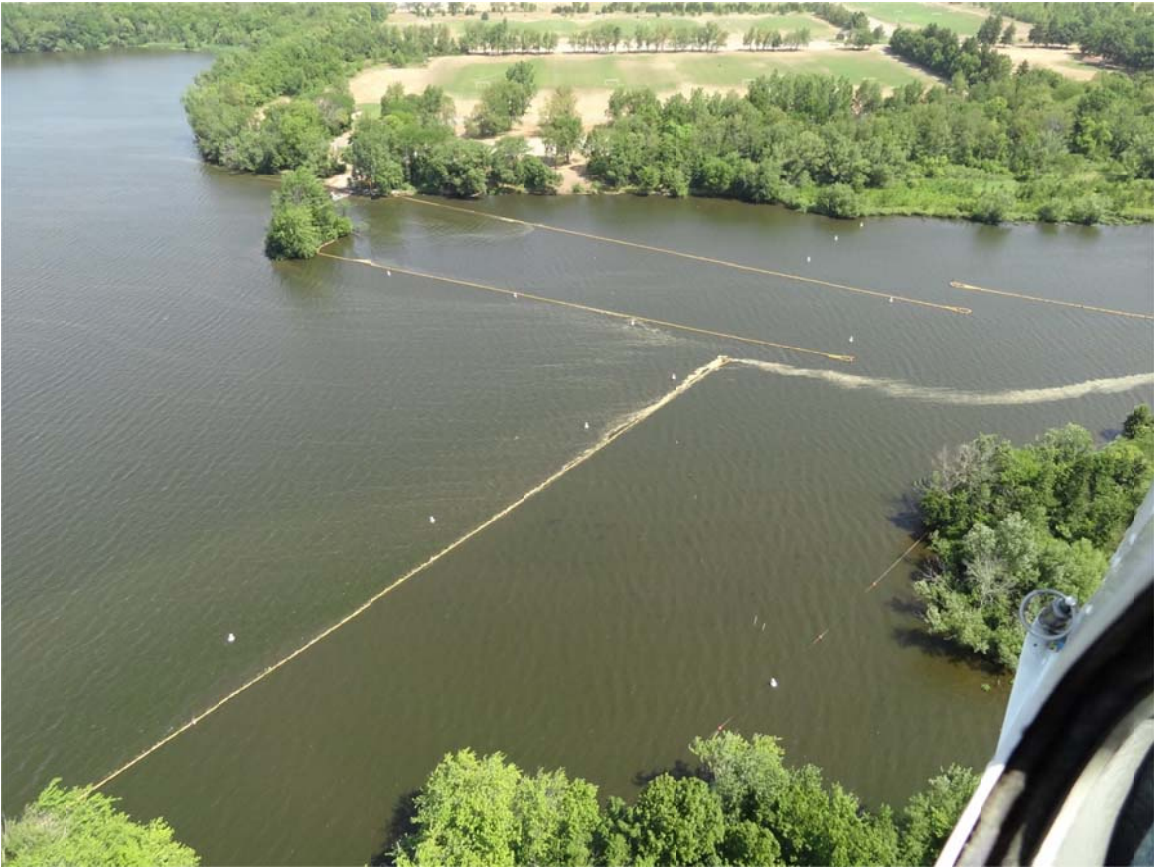
25. E4 Control Point, and organic debris blowing across lake from west to east.

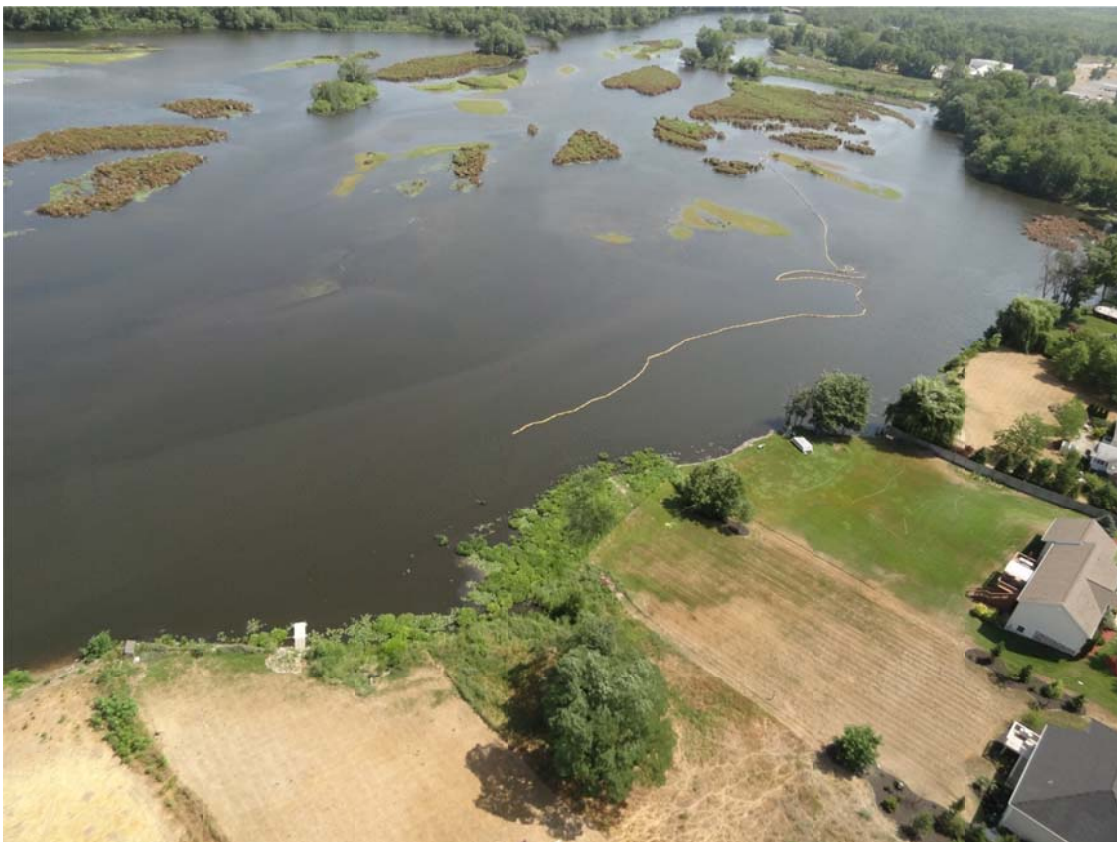
26. Morrow Lake Delta, containment boom staged for installation.
